# Case Study

## Multi-Site Complex Repairs & Bund Containment

Regional DNO Substation

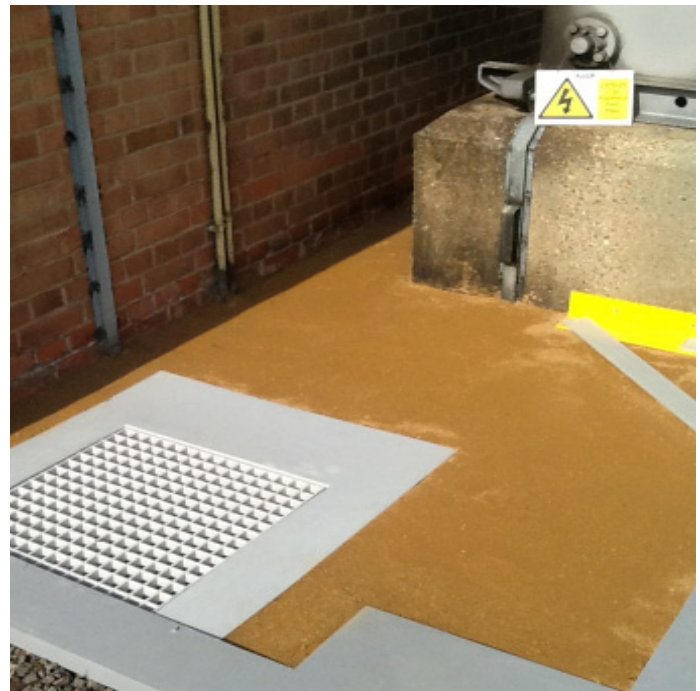
All bunds were then tested for water-tightness using a large

volume of water contained within the bund for 8 hours.
