Case Study Tank Lining

Brayfield Farm, Bucks

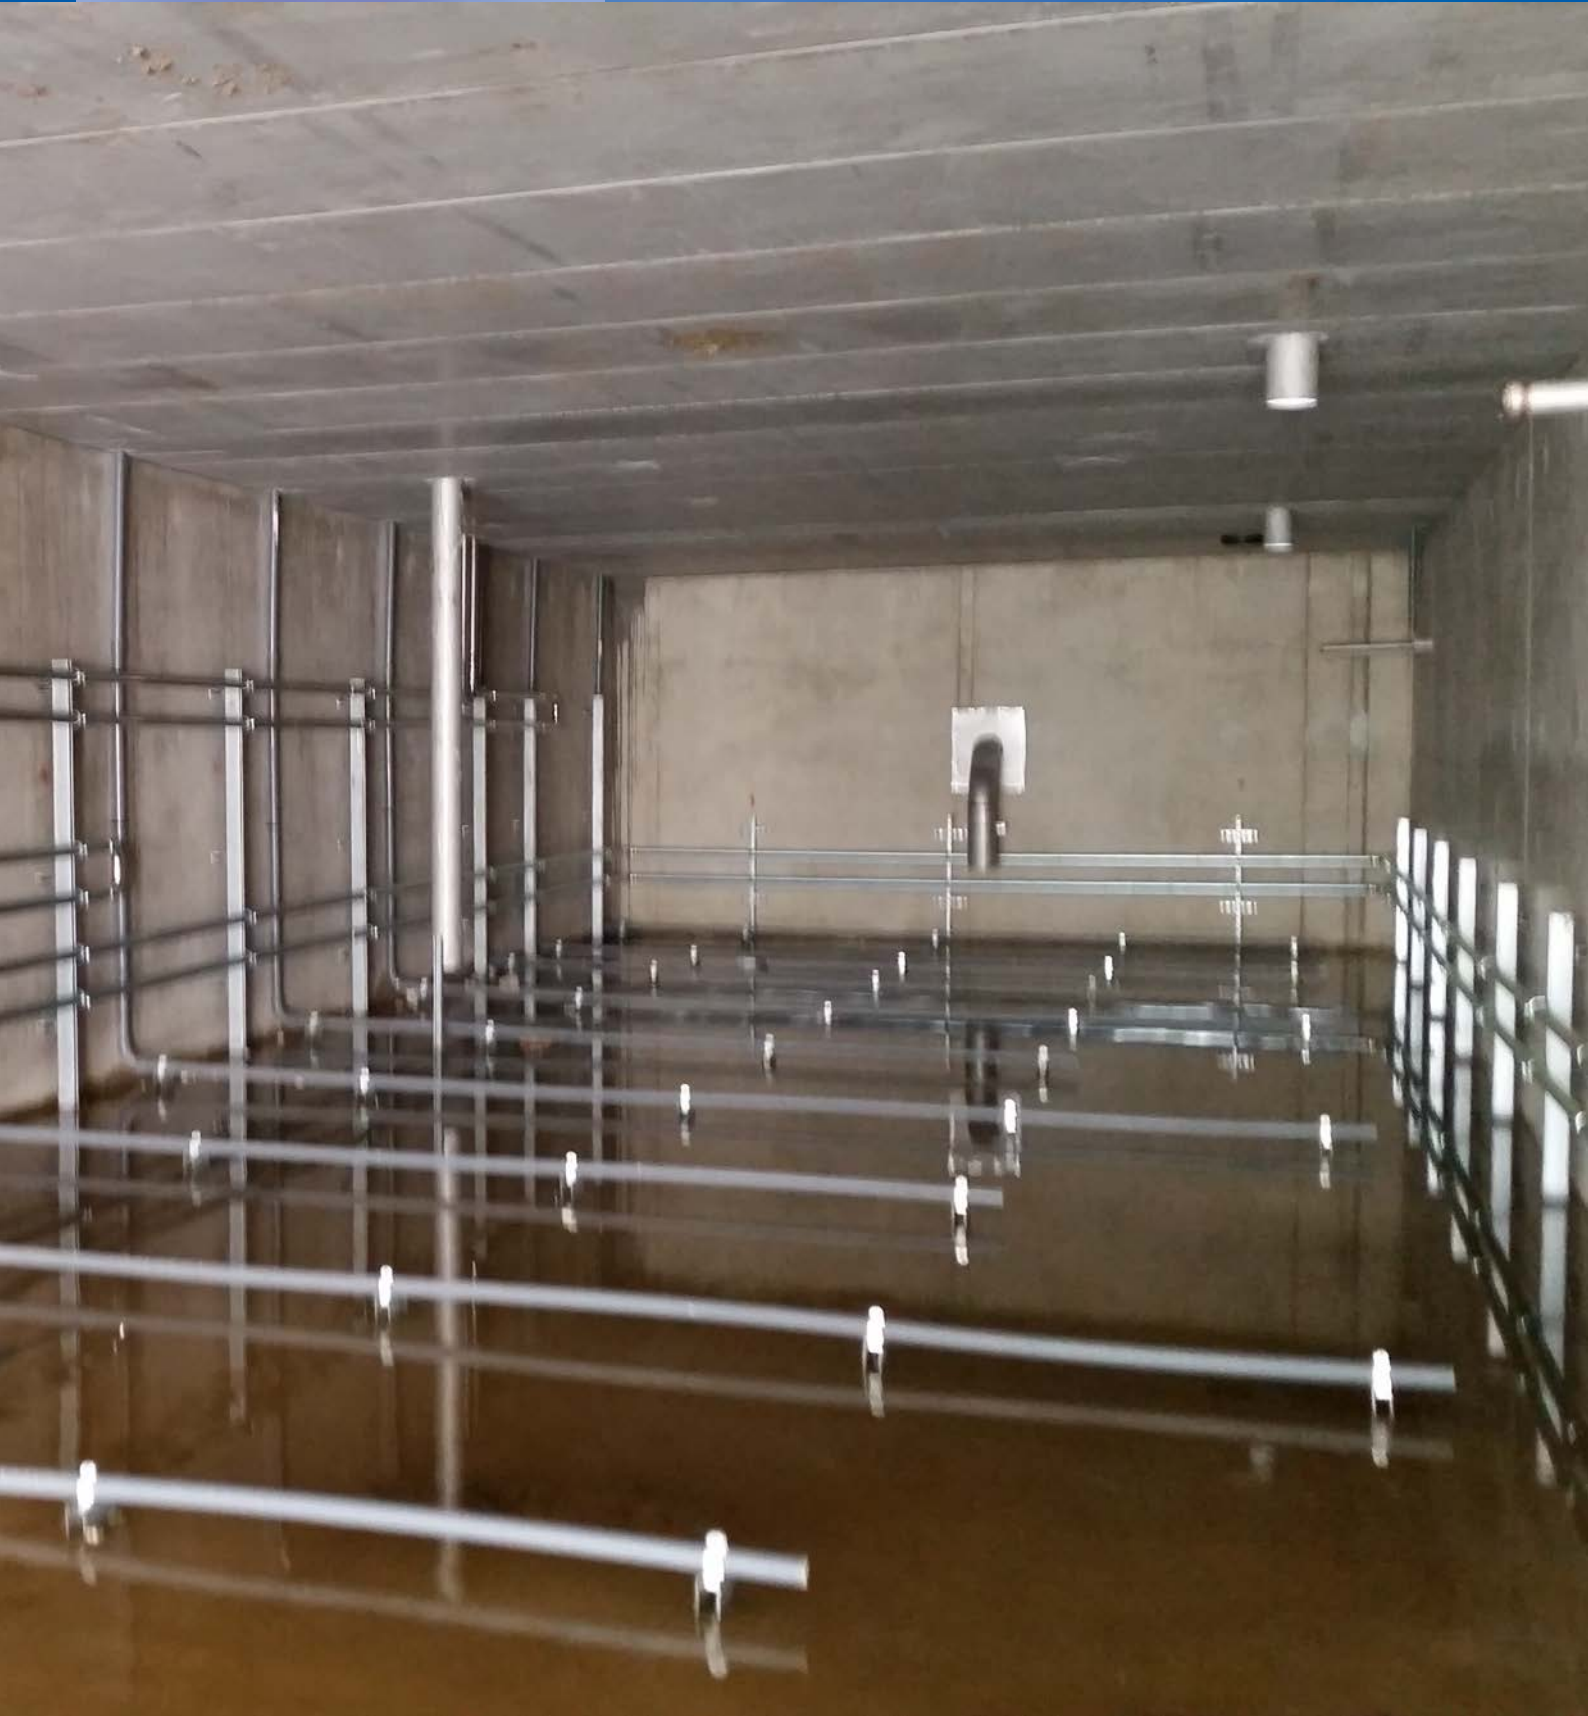
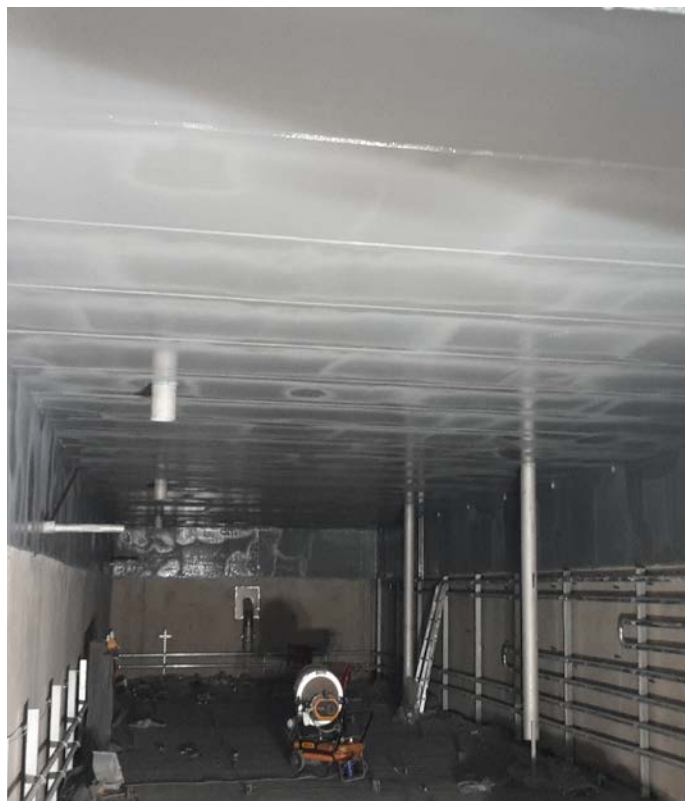
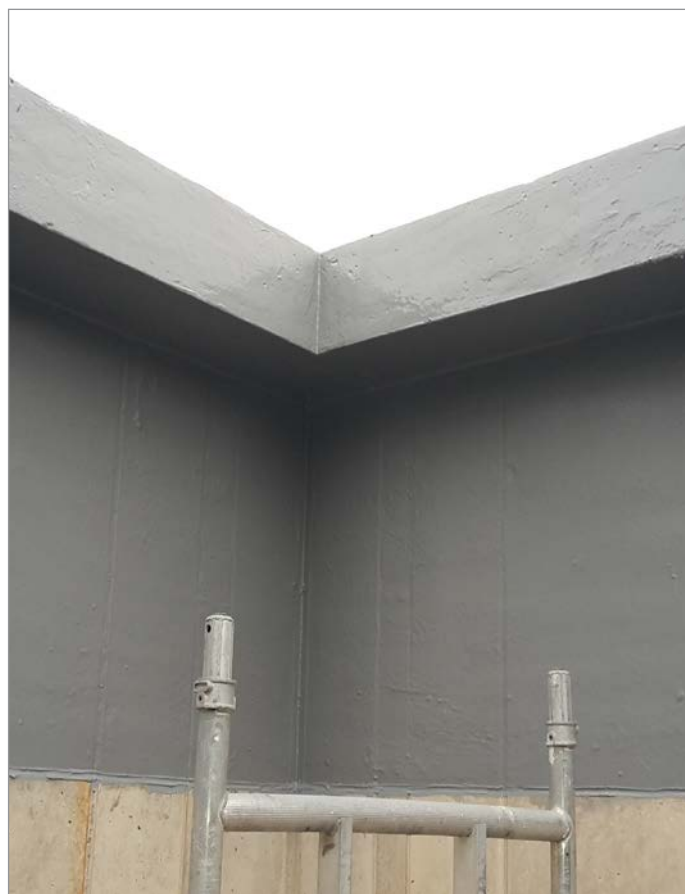
As is often found in this type of sectional concrete construction the joints above the liquor level are the first things to fail due to either ground movement or corrosion, in addition the cement matrix of the concrete in the gas space had been attacked by Hydrogen Sulphide leaving exposed friable concrete.

Adalline 400 Polyurea (CE marked) was selected due to its high tensile strength independently tested and verified crack bridging capabilities, this along with being waterproof and resistant to H₂S made it the ideal choice. The work on the Tank had to be done as quickly as possible thus minimising it's time off line.

Preparation involved high pressure water jetting (6000psi) to remove weak surface latents and contaminants.

The surface was then dried with the use of indirect heaters and finally vacuumed to remove dust and debris. 250µm primer coat of EP90 epoxy primer was then applied to all surfaces in preparation of the sprayed Adalline 400 polyurea membrane. The nominal 2mm polyurea coating was applied in a single operation. As the material gels in 3-5 seconds and can be foot trafficked within a couple of minutes, it allowed for the holiday free spark test to be carried out immediately after applying the coating.
