# Case Study

## Bund Screeding and Chemical Bund Lining

### Kerry Foods, Tenbury Wells

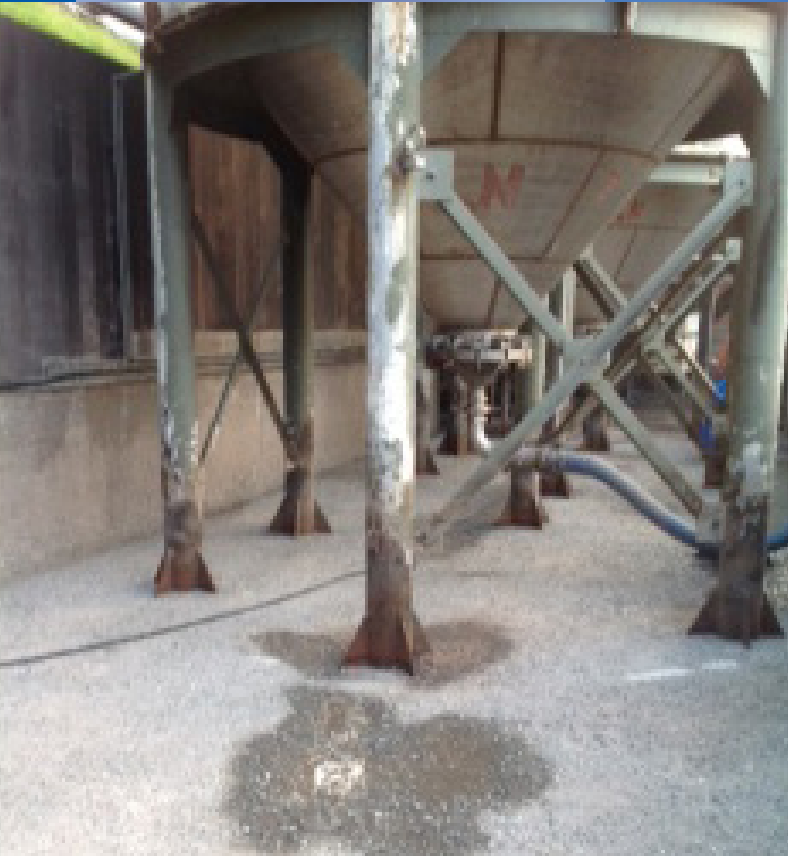
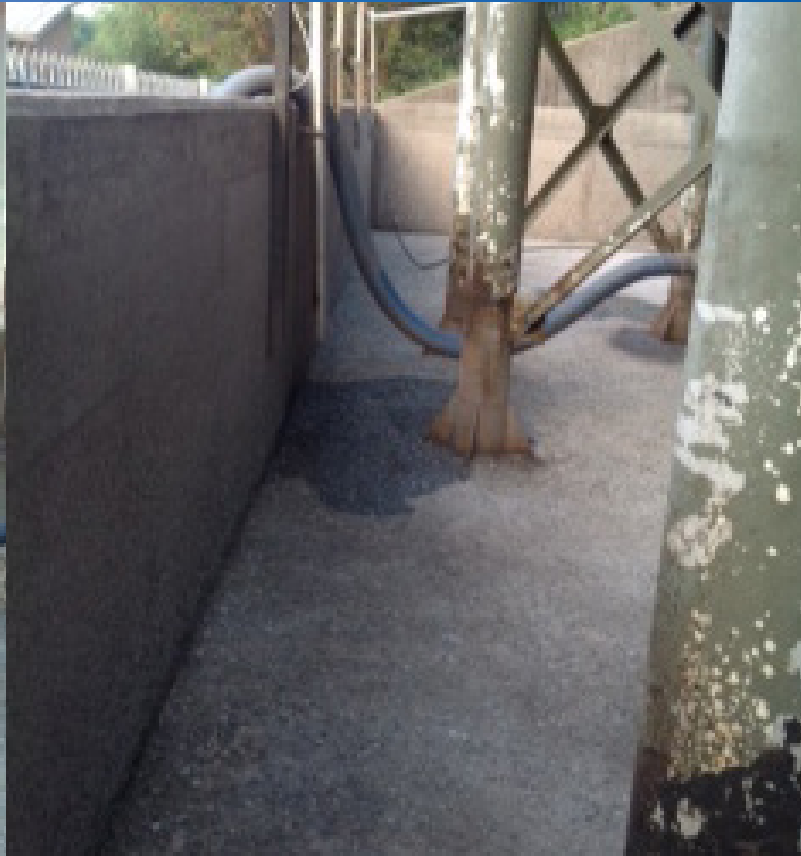
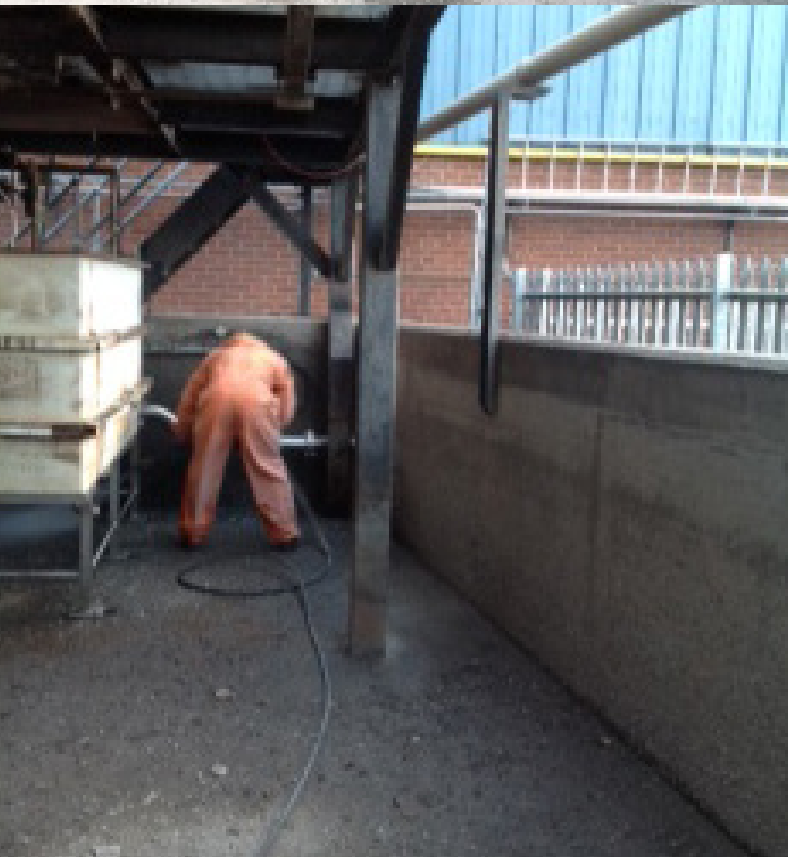
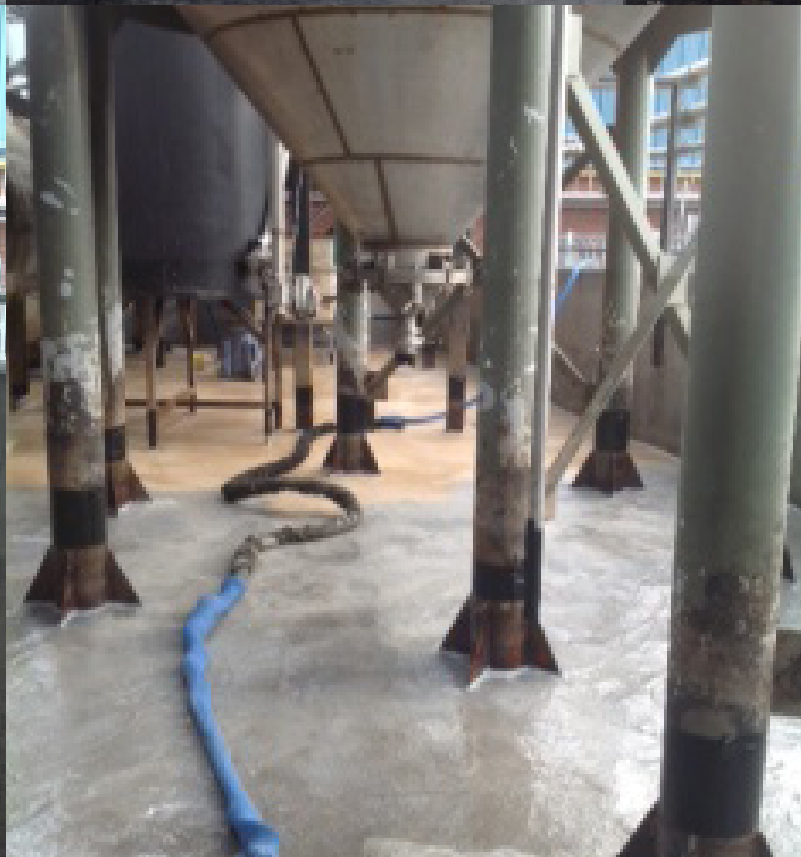
After years of leaks and spills from Acidic Effluent Bund from the steel tanks which blended the yoghurts made on site. The concrete wall and base surrounding the manufacturing equipment had eroded and started to come away from the floor which meant that gaps were left in between, making it a hazard if a bigger spill was to occur leading to contamination outside the Bund.

To avoid future hazards and potential leaks and spills escaping the bund. Adler & Allan undertook a full site survey and recommended that the site floor and walls within the bund should have high performance screed. Due to the size of the bund, the cost of spraying the entire bund with A600 would have been very costly, so our team advised simply using a high performance screed to the eroded floor and wall, giving an even flat surface and then applying the lining system around the sides of the bund to create a wall to floor seal.

An Adler & Allan team were dispatched to site where they firstly carried out a three stage wash using bleach and acid to ensure all surfaces were uncontaminated to prepare the surface for lining. The team then prepared the substrate using technical drawings to establish and set out levels accordingly. The bund surfaces were treated with primer and screeding to walls and base carried out. Rallithane was applied to all angles and joints to create 45° angles at interface base and wall.

The primer was then applied with a fine grit to ensure a mechanical key for maximum adhesion inside the bund. The team then taped off and covered up Kerry Food assets to avoid any over spray of the polyurea. The polyurea coating system was spray applied, using a north to south, east to west motion to ensure an even build-up of polyurea coating until a 2000 micron coating was achieved. At 2000 microns A600 is 100% waterproof and gives a chemical resistance coating. A gel coat was applied to the A600 Chemical Coating with a heavy broadcast of quartz stone creating external anti-slip surface for Kerry Food engineers to carry out any necessary maintenance in a safe environment within the bund. The polyurea coating comes with a warranty of up to 10 years extending the lifecycle of the asset.

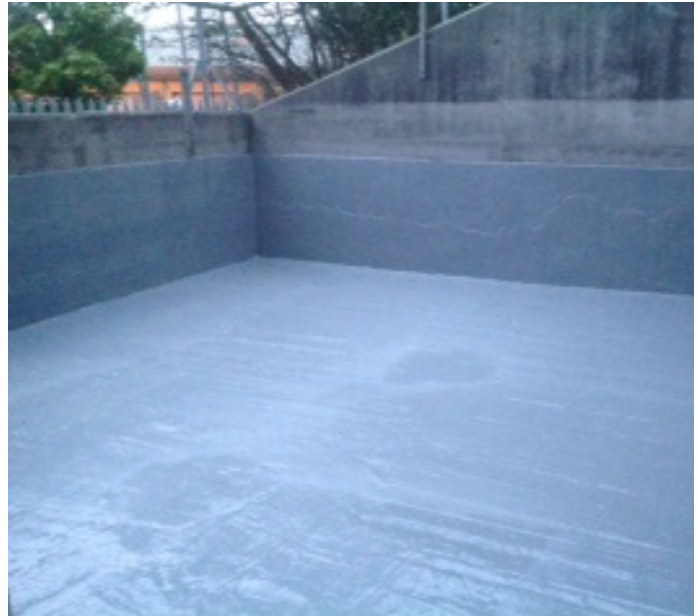
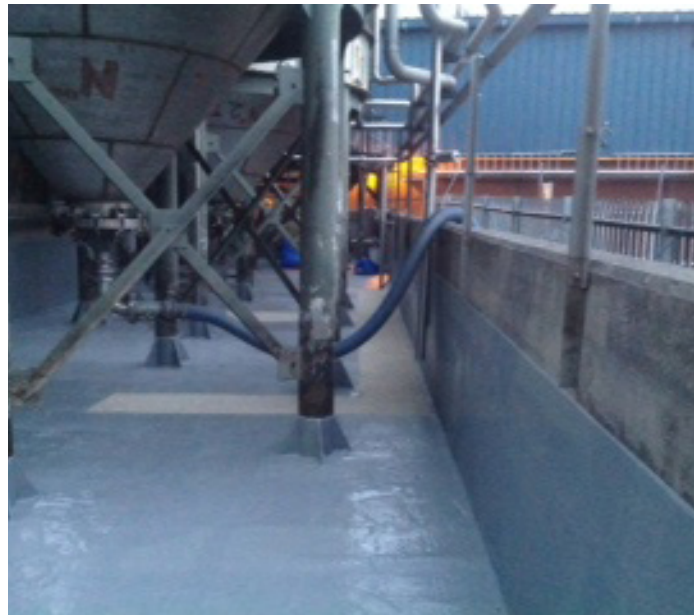
Once the whole area was sprayed we carried out a validation report which consisted of dielectric testing and hydrostatic water test to ensure that no water could escape from the bund. Both tests were successfully carried out and the lining was found to be secure and the bund fit for purpose. With the new lining intact, the lined bund around the equipment will benefit from elongated life and increased structural integrity for many years to come.
