Case Study

Asset Refurbishment

Oxford Sewage Treatment Works
Thames Water

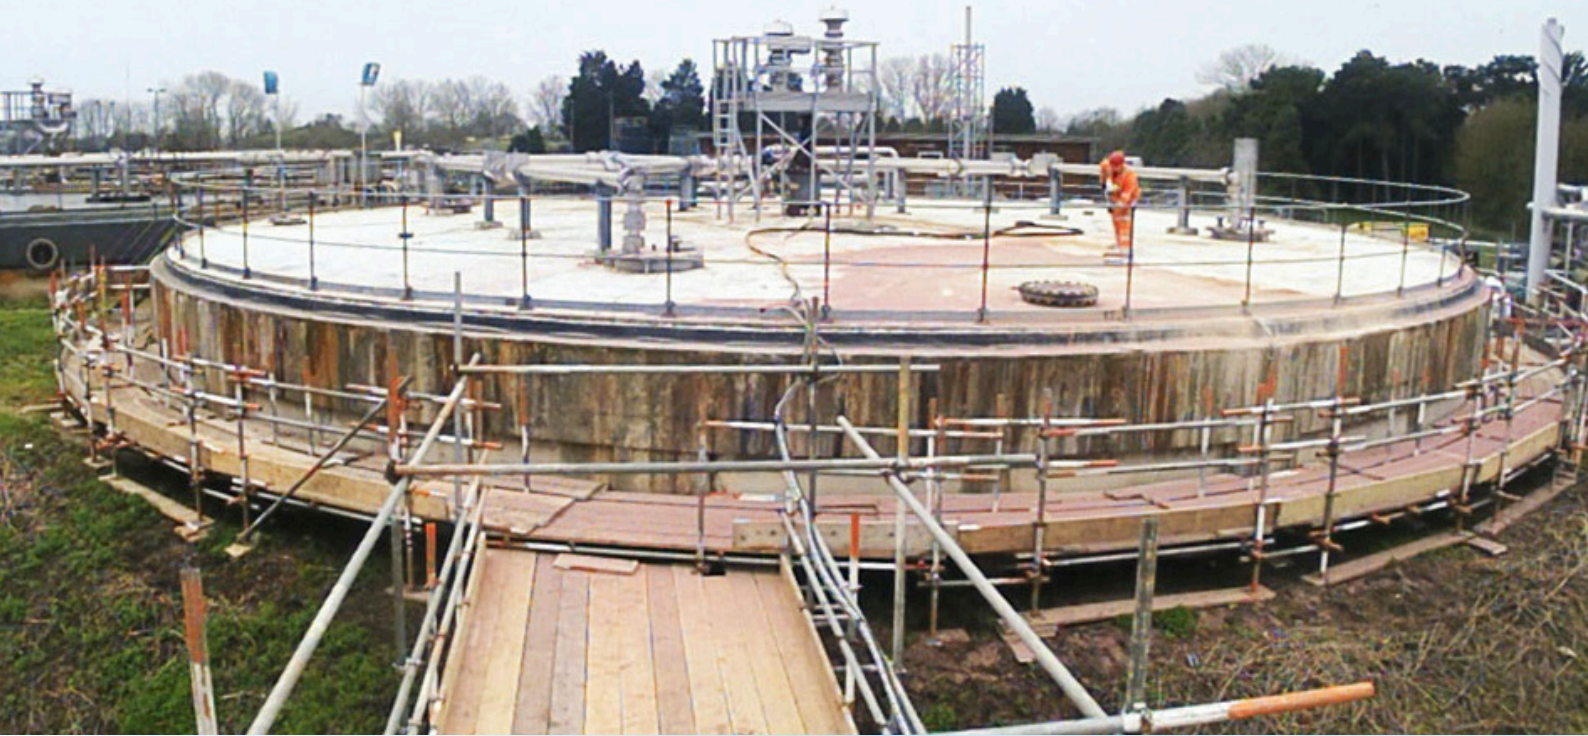
Before

The roof of the Digester had become badly worn over its current life cycle and there was evidence of surface cracking that if untreated could have potentially compromised the containment of methane produced as part of the digestion process.

Adler & Allan's solution was to coat the roof area and surrounds with their specialist polyurea Adalline 400 lining to provide robust and resilient refurbishment. Adalline 400 is a high tensile, high elongation, high build, fast-set elastomer. It is specifically formulated to provide a tenacious bond to surfaces, providing a cost effective, flexible, tough, resilient monolithic membrane with water and chemical resistance. Adalline 400 is an excellent choice of elastomer to topcoat structures for protection, primary containment and extension of asset life.

- The roof and surrounds of the digester were shot blasted to remove contaminants and prepare the surface for coating.
- Cracks and visible defects were then repaired using conventional civils techniques.
- Once the areas had been satisfactorily repaired, they were treated with a Stainguard primer to maximise adhesion, with existing assets sealed using a Rallithane jointing compound to soften profiles.
- Finally, a 2mm coating of Adalline 400 polyurea coating was applied across the treated area. Subsequent to coating, all surface areas were validated using a dielectric testing method to provide a 100% fully warranted containment solution.

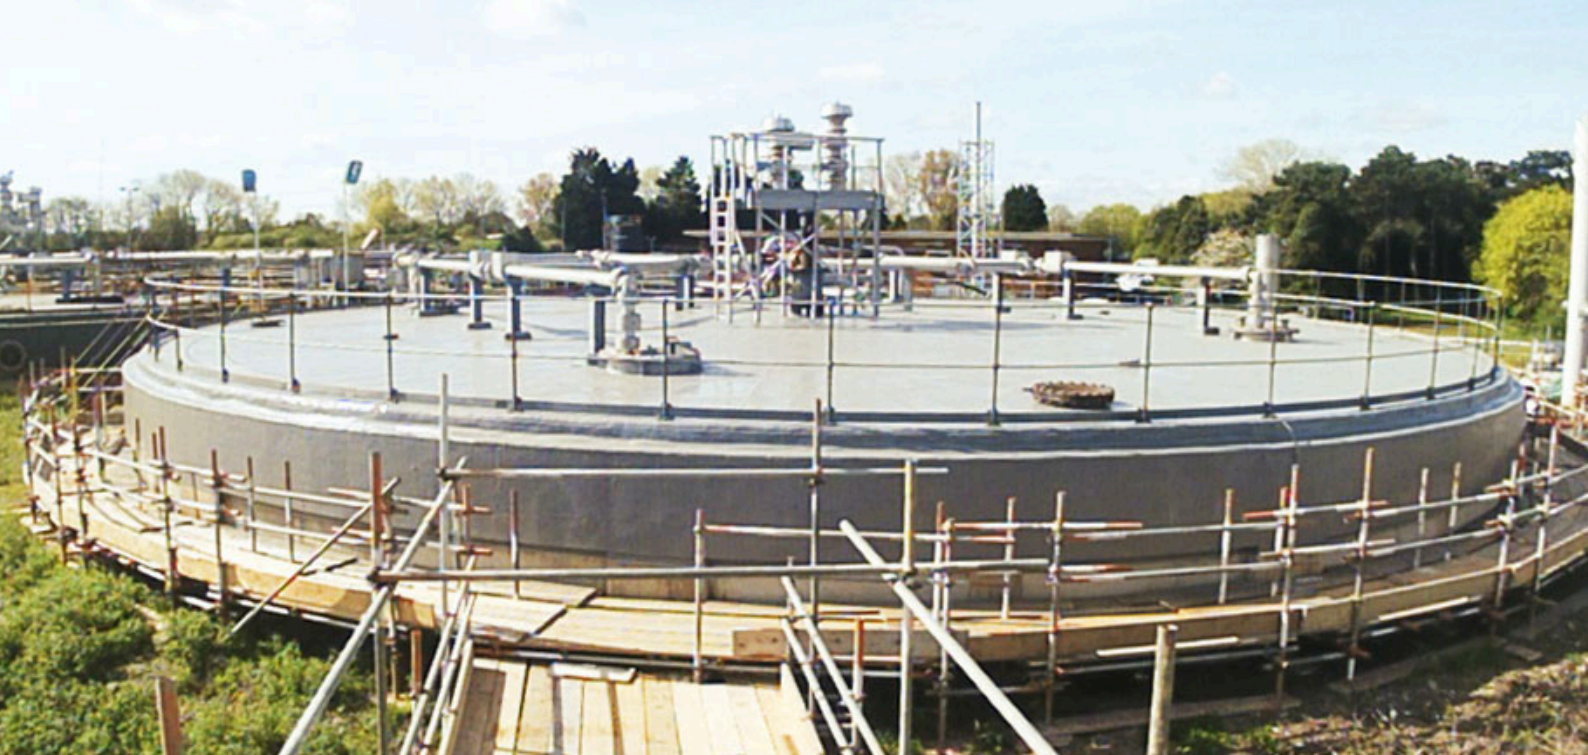
After

The lining has extended the life of the digester by a minimum of 10 years at a fraction of the cost of replacement or a traditional civils remediation that would have necessitated lengthy operational downtime. The quick setting properties of Adalline 400 allowed the work to take place with minimal operational disruption and a full return to service was achieved within 24 hours. Ongoing co-operation and liaison throughout the three week project period ensured that all deliverables were met safely, efficiently and on time.
